NUMBER: 23-004-04

Cup Holder Bind Or Sticks

This bulletin involves adjusting the instrument panel trim to provide clearance for the cup holder.

2004 (DR) Ram Truck

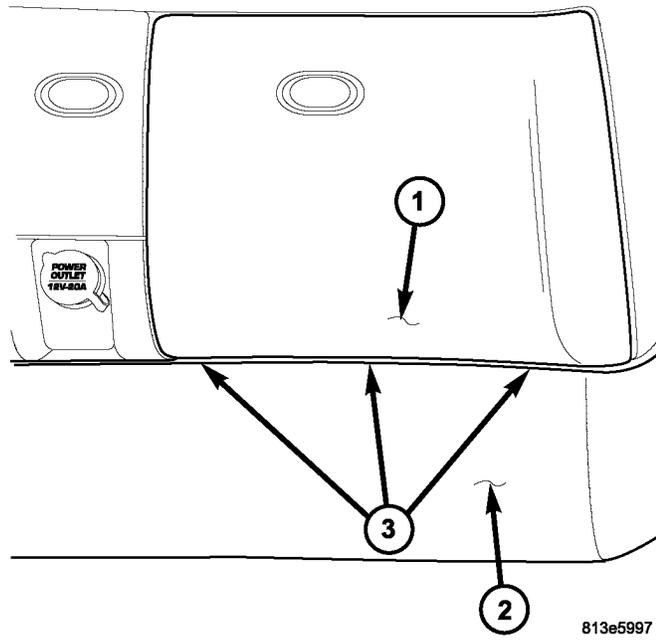
Fig. 1 CUP HOLDER/ACM COVER

- 1 - Cup Holder
 - 2 - Airbag Control Module Cover
 - 3 - Gap Between Cup Holder and Airbag Control Module
-

1. Using a plastic trim stick, or suitable tool, gently pry on each side of the Airbag Control Module (ACM) cover located under the cup holder and remove the ACM cover.
2. Operated the cup holder with the ACM cover removed. If the cup holder now operates freely, there is an interference between the ACM cover and bottom of the cup holder. If the cup holder binds with the ACM cover removed, proceed to Step 6.
3. Install the ACM cover and inspect the area where the cup holder and the ACM cover come together (Fig. 1). There must be a gap between the ACM cover and the bottom of the cup holder. If the ACM cover is in contact with cup holder, try realigning the cover by pushing the bottom of the cover towards the front. if this provides a gap and the cup holder now operates freely, the repair is complete. If the gap cannot be achieved by adjusting the ACM cover proceed to the next step.

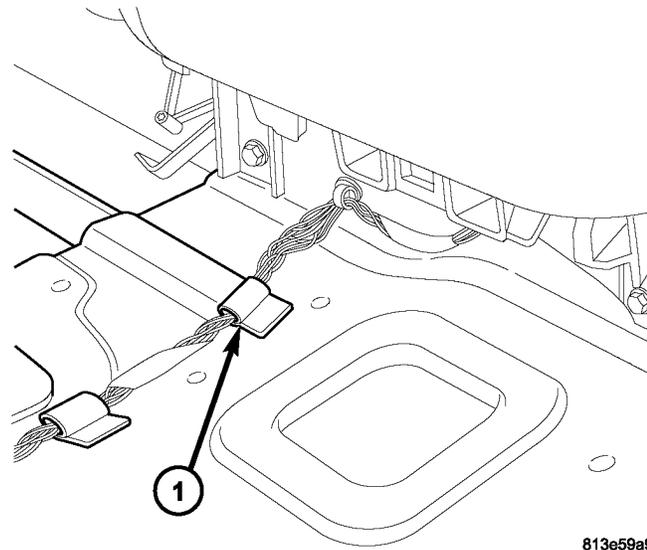
Fig. 2 ACM WIRE HARNESS

4. The ACM wire harness runs rearward along the left side of the tunnel under the carpet. (Fig. 2). Rub your hand along the carpet in the area of the bottom of the ACM cover and feel for the harness. If the harness can be felt, it may be pushing the ACM cover upward and into the cup holder. If this is happening it may be necessary to reroute the harness or remove carpet padding from the area.

5. Roll the carpet back and make sure that there are no plastic retainers in the area that could cause the interference. If a retainer is present remove it. Make sure that the harness is not sitting on a raised portion of the floor. If it is, reroute the harness to a lower area on the floor. Remove the any carpet padding from the area where the harness contacts the carpet to gain additional clearance. This should provide the clearance needed. and complete the repair.

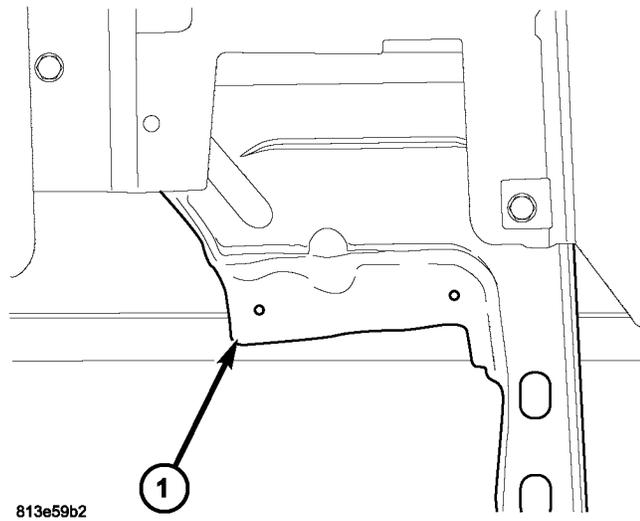
Fig. 3 CUP HOLDER BRACKET

1 - Possible Location of Bent Bracket

6. Remove the cup holder.
7. Operate the cup holder out of the vehicle. If the cup holder still binds it must be replaced. If it operates freely, inspect the metal bracket where the cup holder fasteners attach as shown. (Fig. 3). If the bracket is bent, it could cause the cup holder to twist or distort when the screws are installed. Straighten the bracket and install the cup holder. If the cup holder operates freely the repair is complete. if the cup holder still binds, it must be replaced.
